Manhole Inspection Summary

Manhole # S15Q__001MH

Insp Date: **12/9/08 2:51 PM**

Location Address: **2780 WILKENS AV**

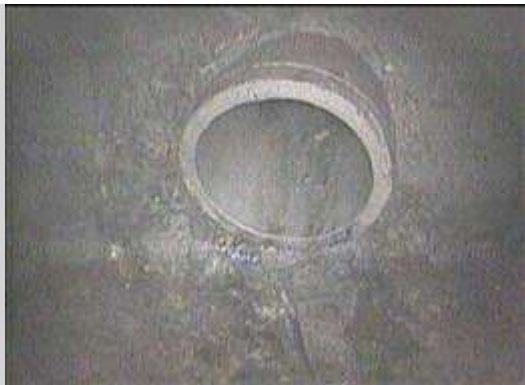
4 O'Clock Inflow

Pipe Height: **8.4** (in.) Rod and Bar (Angled)
Pipe Material: **Clay** ☐ Pipe Lined
Invert Depth: **13.03** (ft.) Flow Characteristics: **Slow**
Deposits: ☒ None ☐ Mud ☐ Sludge ☐ Debris ☐ Grease
Silt Depth: **0** (in.) Deposits Extent:
Infiltration: **None** Pipe Seal Cond: **Sound**
